## **Realistic Safe-Separation Distance Determination for Mass Fire Hazards**

by  
Thomas L. Boggs  
*New Directions Technology, Inc.*  
*Ridgecrest, CA 93555*

**MARCH 2013**

NAVAL AIR WARFARE CENTER WEAPONS DIVISION  
China Lake, CA 93555-6100

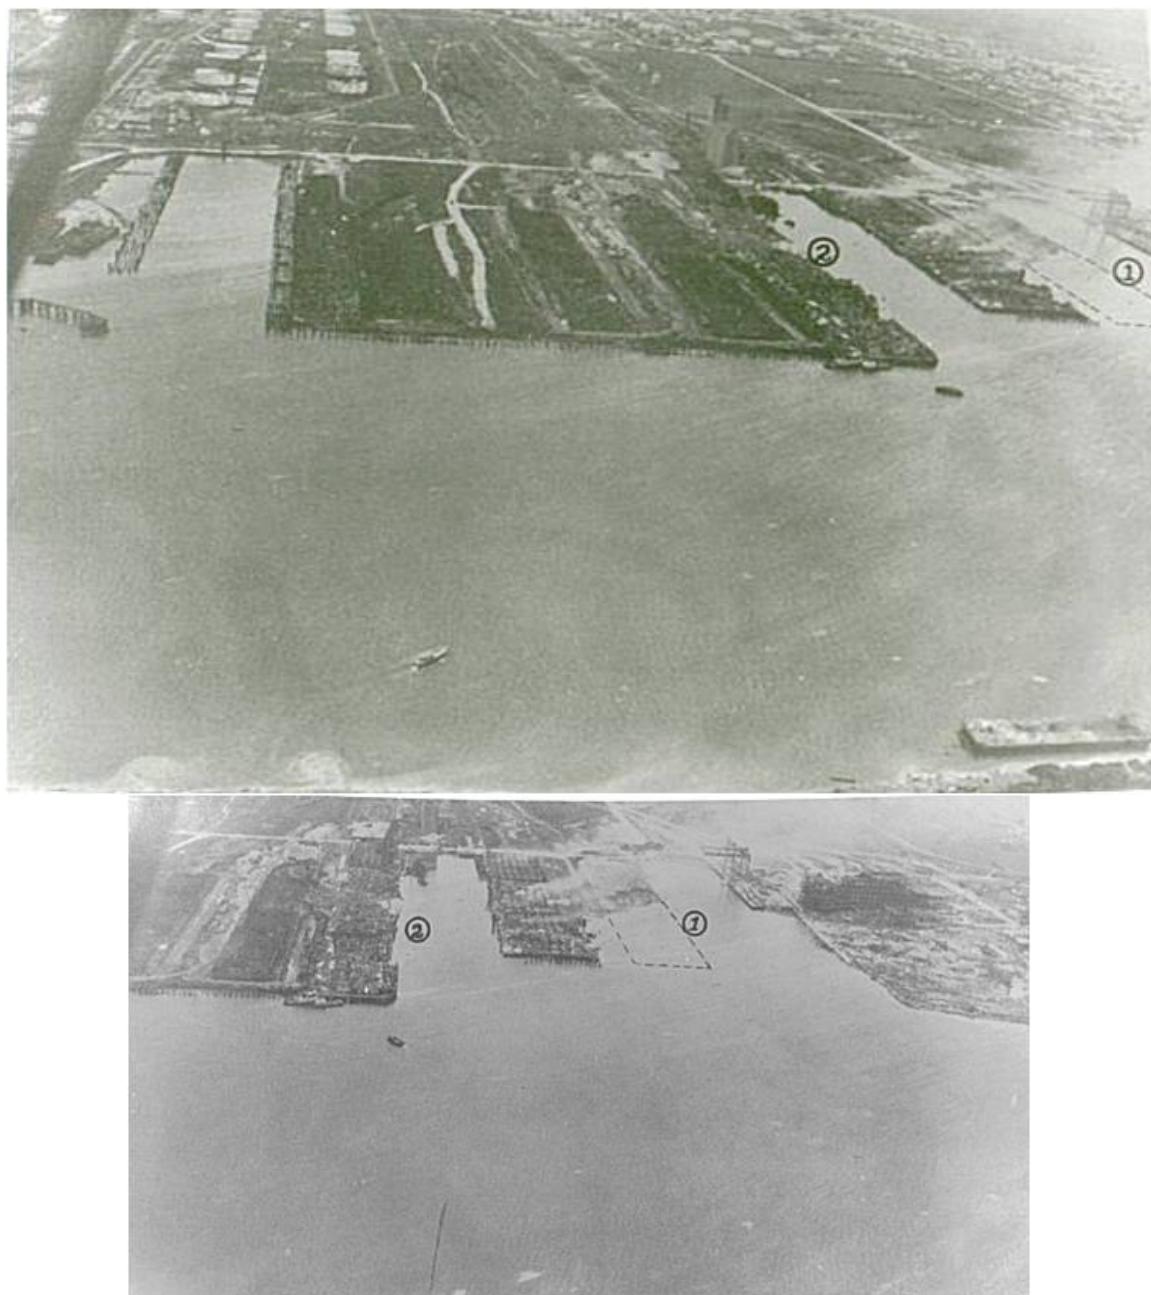
But the disaster was not over yet. There was another Liberty ship, the *High Flyer*, moored at the adjoining slip, about 600 feet (200 meters) from where the *Grandcamp* had been berthed. The *High Flyer* was loaded with 1,800 tons of sulfur [one account said 2,000 tons of sulfur] and 961 tons of AN. The force of the *Grandcamp* explosions had torn the *High Flyer* from its moorings and caused it to drift across the slip where it lodged against another ship, the *Wilson B. Keene*. Later in the afternoon, flames were noticed coming from one of the holds of the *High Flyer*. Unfortunately, nothing was done until about 11:00 p.m., when tugs tried to pull the burning ship from the docks. The efforts to pull the *High Flyer* out of the harbor failed. By 1:00 a.m. on 17 April, flames were shooting out of the hold. Ten minutes later the cargo of the *High Flyer* exploded in a blast that witnesses thought even more powerful than that of the *Grandcamp*. Casualties were light because by now the area had been evacuated. However, the blast resulted in further fires and property damage. The fires burned for days. Figure 127 shows the port area after the disaster. The 1 indicates where the *Grandcamp* had been berthed while the 2 was the location of the *High Flyer*.

FIGURE 127. Texas City Port Area After the Disaster.

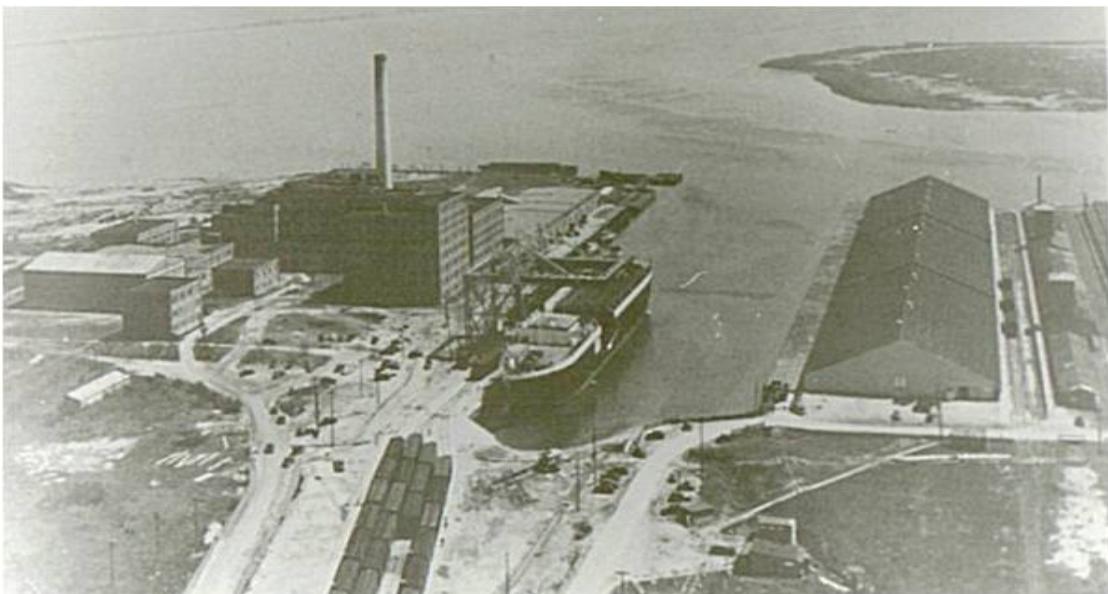
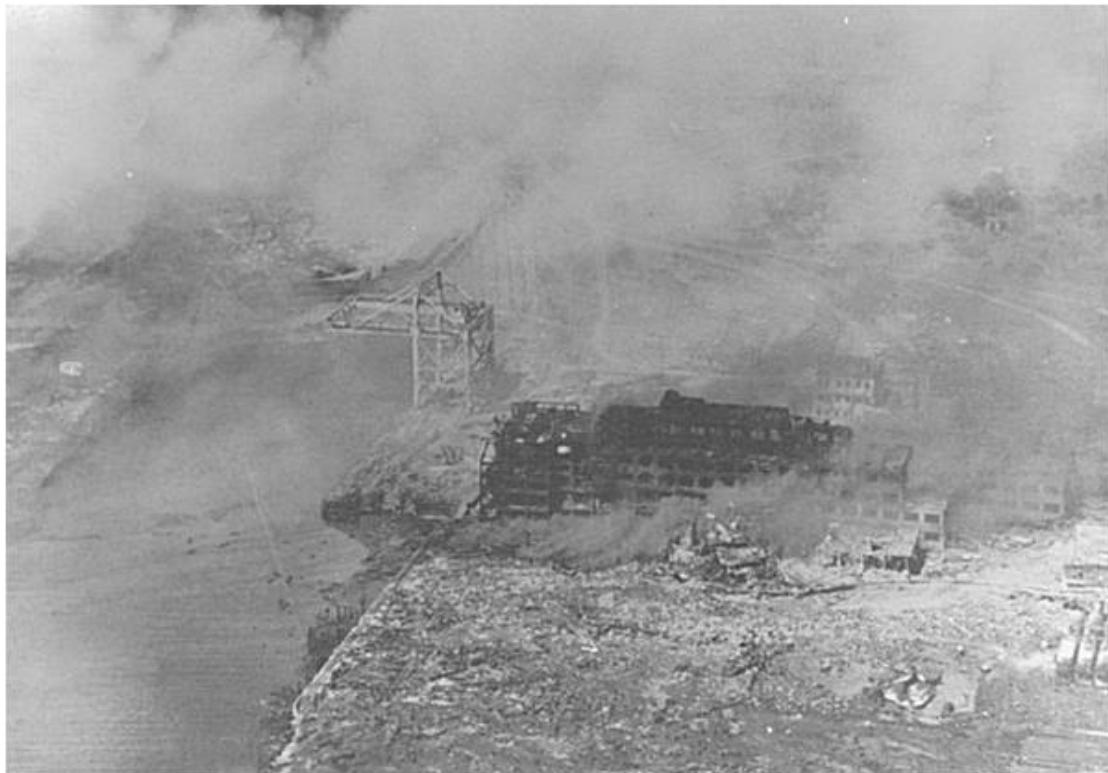
FIGURE 128. Monsanto Plant.

Another indication of the damage caused by this disaster is shown in Figure 128, which shows the adjacent Monsanto plant before and after the disaster.

(a) Before disaster.

(b) After disaster.

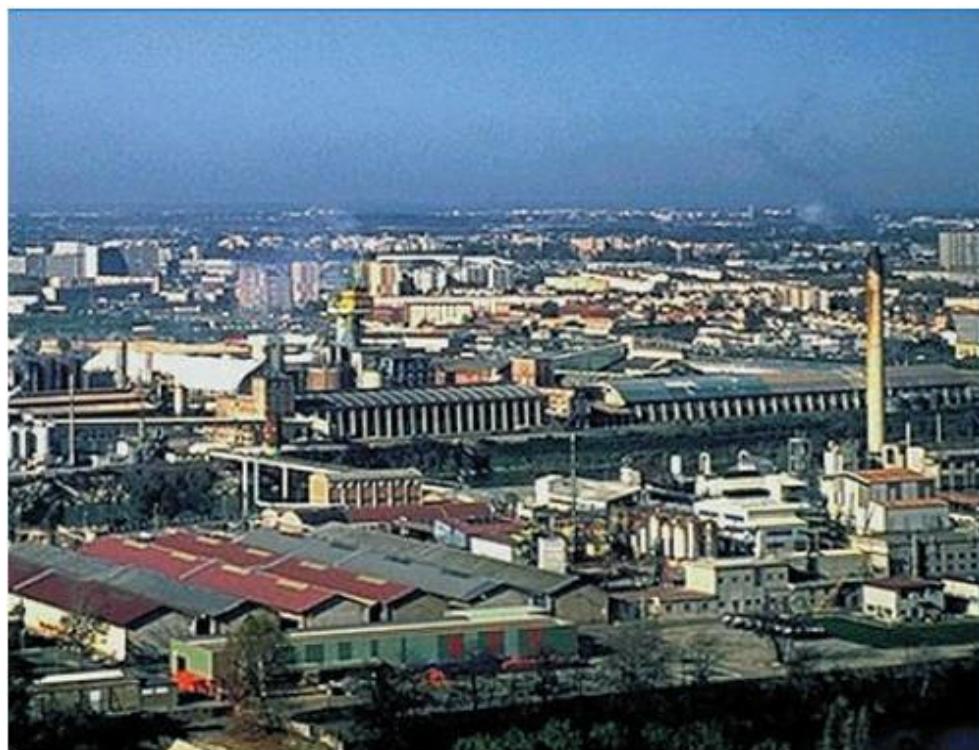
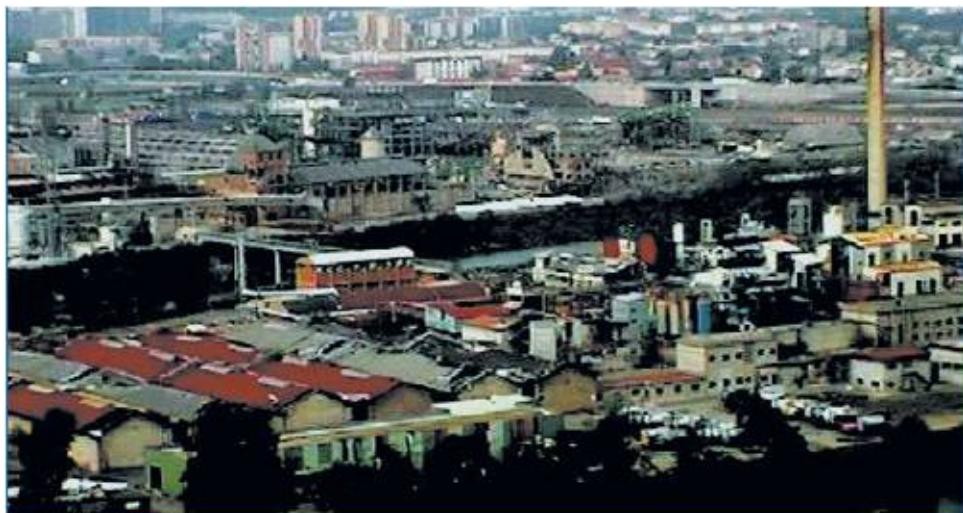
FIGURE 129. AZF Plant, Toulouse, France.

Shed 221 contained about 300 tonnes of AN that did not meet commercial specifications. It was being stored while awaiting shipment to other plants to be used in making compound fertilizers. The explosion left a crater several tens of meters across and was heard more than 40 kilometers from Toulouse. The estimated TNT equivalence was between 20 and 40 tonnes. The explosion registered the equivalent of an earthquake measuring 3.5 on the Richter scale. The explosion caused 30 deaths, including 21 people working in the AZF plant. More than 4,500 people were injured. [Some reports estimated 2,500 seriously injured and the total injured to be as high as 9,000 to 10,000.] Buildings destroyed in the surrounding area totaled approximately 27,000. The cost of damages has been estimated to be 1.5 billion euros. Figure 129 shows the plant before and after the explosions.

(a) Before explosion.

(b) After explosion.

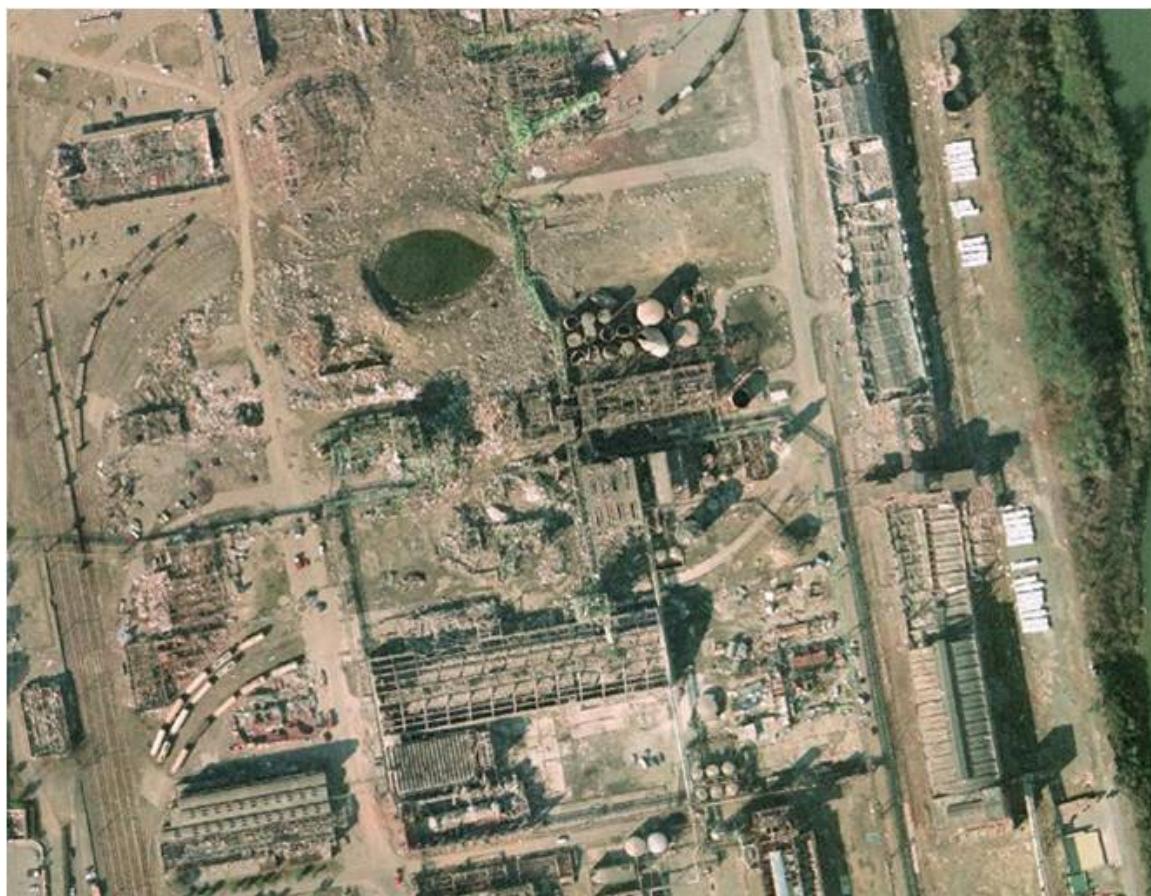
An aerial view of the northern area of the plant, Figure 130, shows the wide spread destruction. Figure 131 shows the destruction at ground level.

FIGURE 130. Aerial View of the Northern Portion of the AZF,  
Toulouse, France After the Explosion.

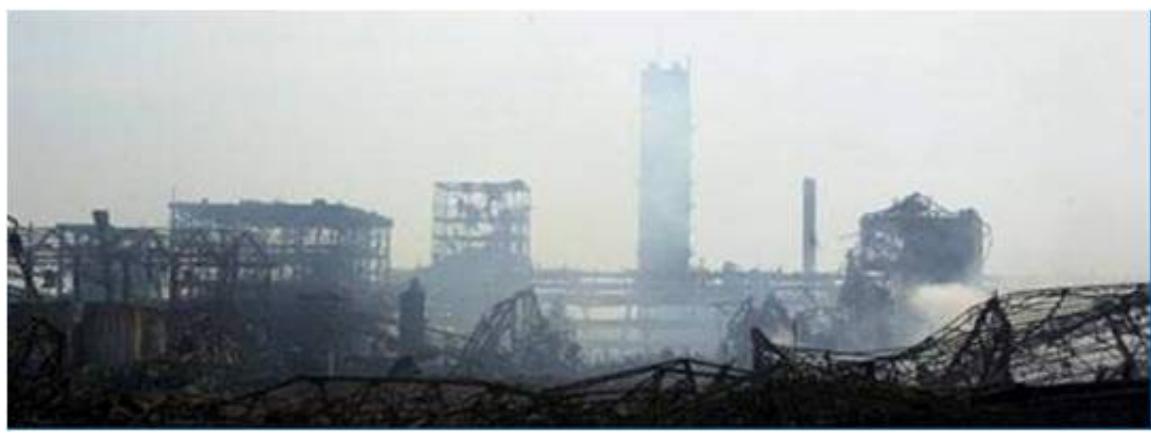
FIGURE 131. Ground Level View Showing the Extent of Destruction  
Due to the Explosion at the AZF Plant, Toulouse.

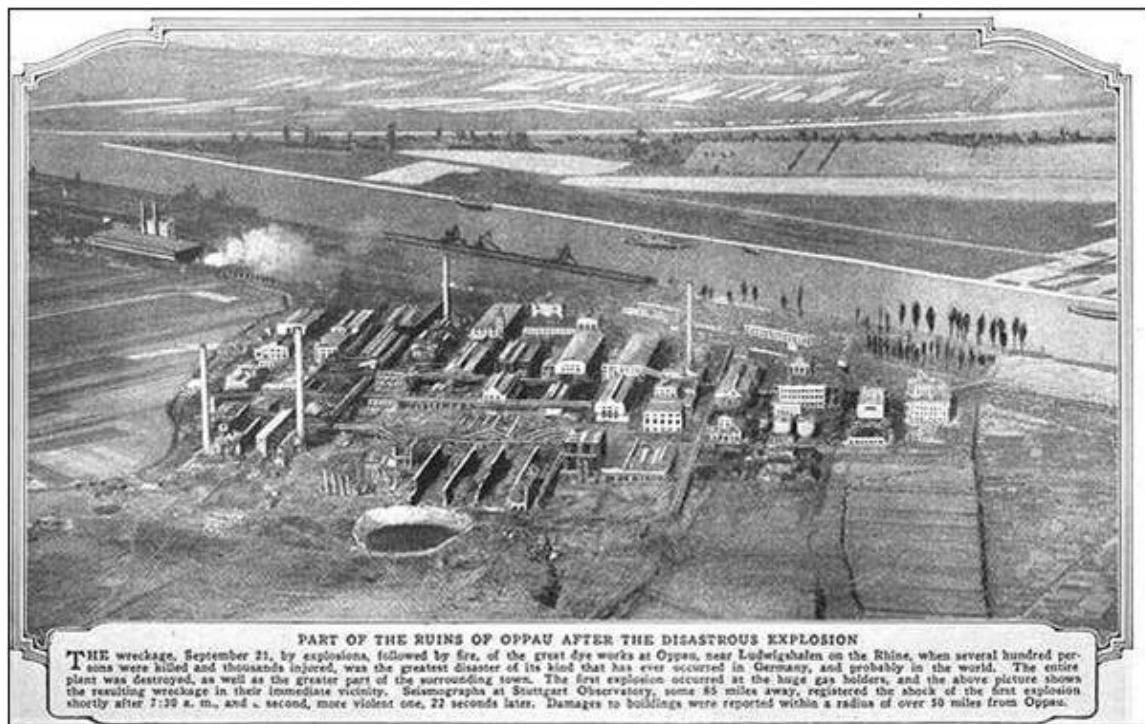
FIGURE 132. BASF Plant After the Explosion. The crater and extent of damage are apparent. This was from *Popular Mechanics Magazine* 1921.

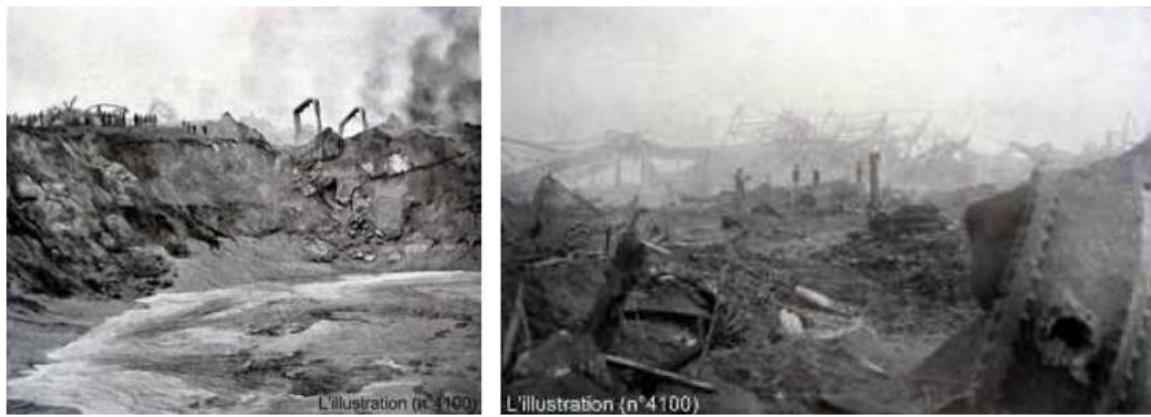
Figure 132 shows the crater and extent of damages to the BASF plant, while Figure 133 documents the depth of the crater and extent of damage at ground level.

FIGURE 133. Crater and Extent of Damage at Ground Level.

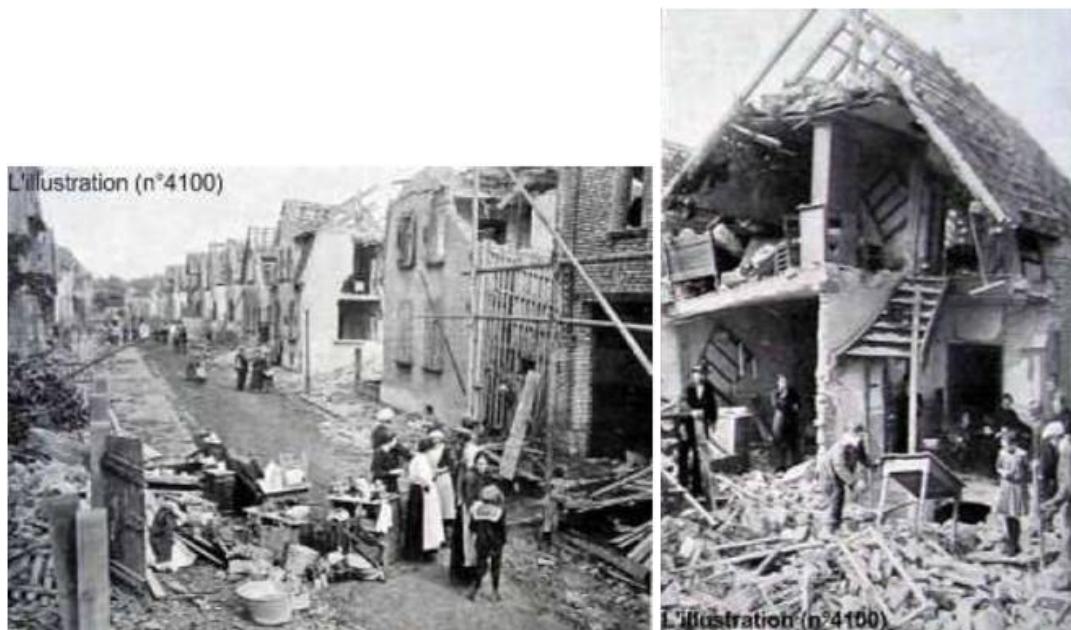
The number of fatalities and injuries reported varied from 430 fatalities in one report to 500 to 600 fatalities and 2,000 injuries in another report to 561 fatalities and 1,952 injuries in two other reports. About 80% of the buildings in Oppau were destroyed. The estimated damage was 321,000,000 marks, or \$1.7 million, at that time. Figure 134 shows some of the damage in the town of Oppau.

FIGURE 134. Damage to Houses in Oppau Caused by the Explosion at the BASF Plant, Oppau.

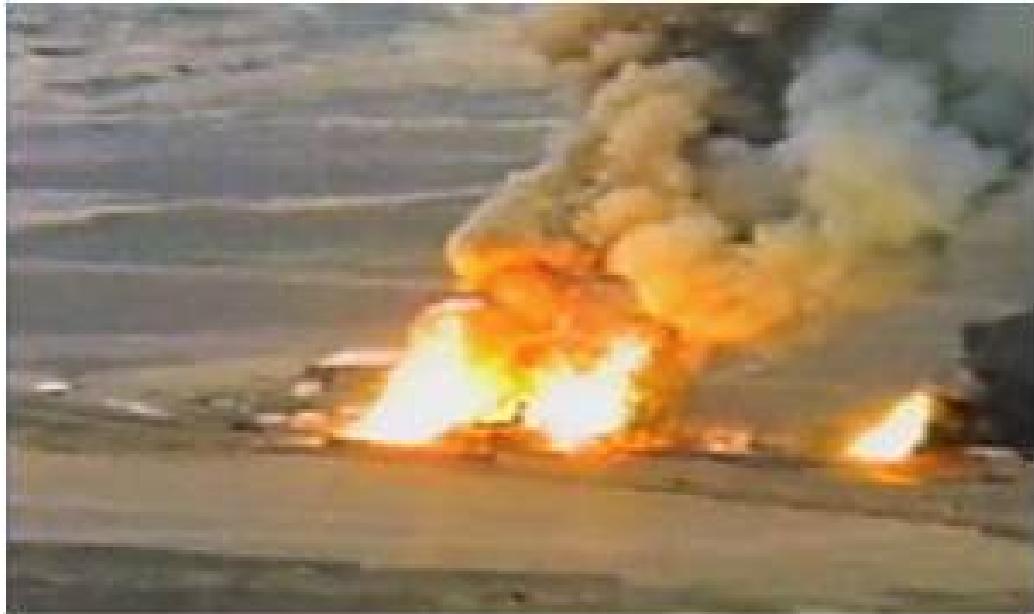
On the day of the accident, a welding crew was repairing the drying process structure that had been damaged by a previous windstorm. The structure was a steel frame with fiberglass panels forming the walls and roof. Sparks/slag from the welding/cutting operation caused a fire to start in the fiberglass that probably had some AP residue. Stiff winds (approximately 17 miles per hour (mph) from the southwest at about 210 to 240 degrees) quickly spread the fire into the area where AP in the 55-gallon HDPE drums was stored.

FIGURE 135. Fire at PEPCON.

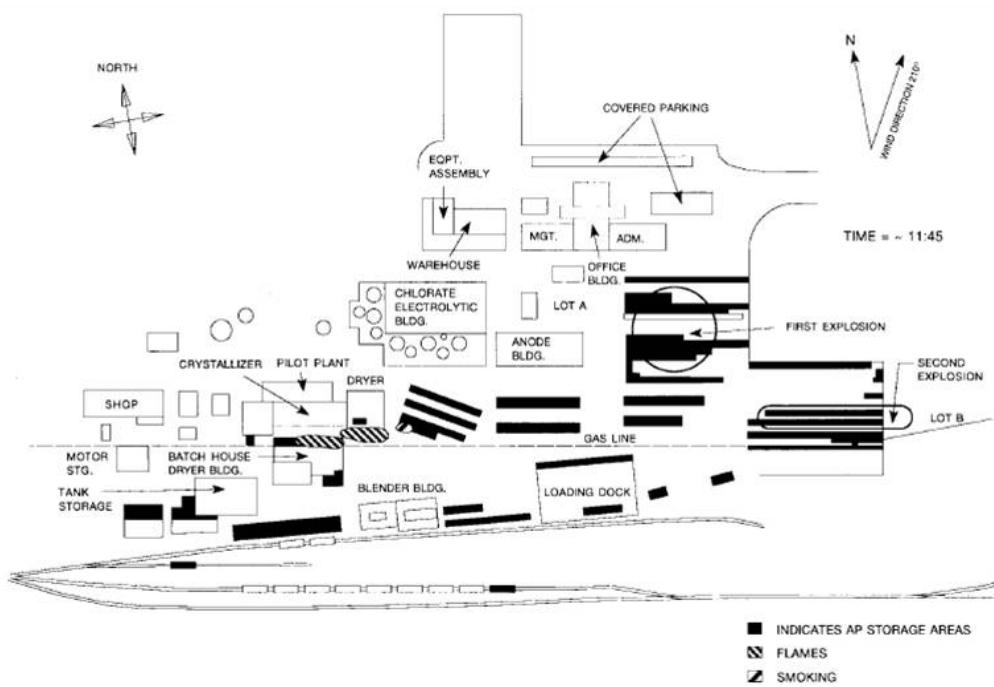
At 11:45 a.m., flames were observed in the AP storage located between the batch house dryer building and the dryer building as shown in Figure 137. As cited in Reference 37, several witnesses observed a burning poly drum in the southwest corner of the batch dryer building. One noted the drum burning looked "like a rocket engine, with flames at least 15 feet high. Other observations indicate fire along the floor from north to south of the batch dryer building, possibly due to a burning drum toppling causing jetting across the floor.

FIGURE 137. Mapping at Time 11:45 a.m. Showing the Buildings, AP Storage Areas, and the Fire Adjacent to the Crystallizer and Dryer Buildings (Reference 37).

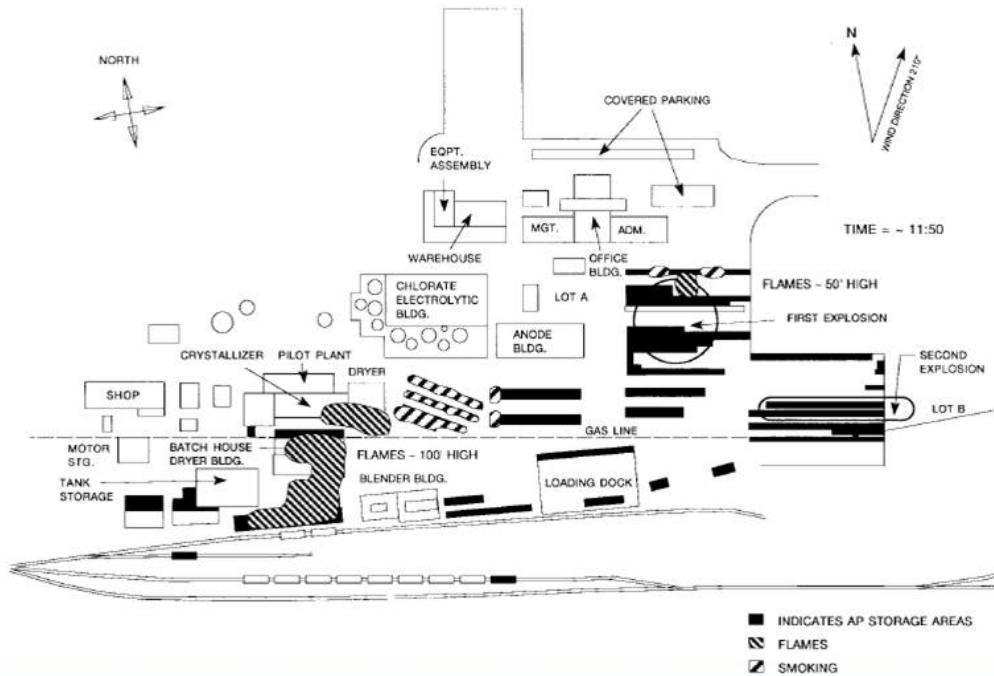
Figure 138 shows the snapshot at 11:50 a.m. By this time most of the poly barrels near the batch house dryer building and dryer are on fire and the drums to the east are starting to show signs of smoke.

FIGURE 138. Mapping at 11:50 a.m. Showing Buildings, AP Storage Areas, Flames, and Smoke Locations (Reference 37).

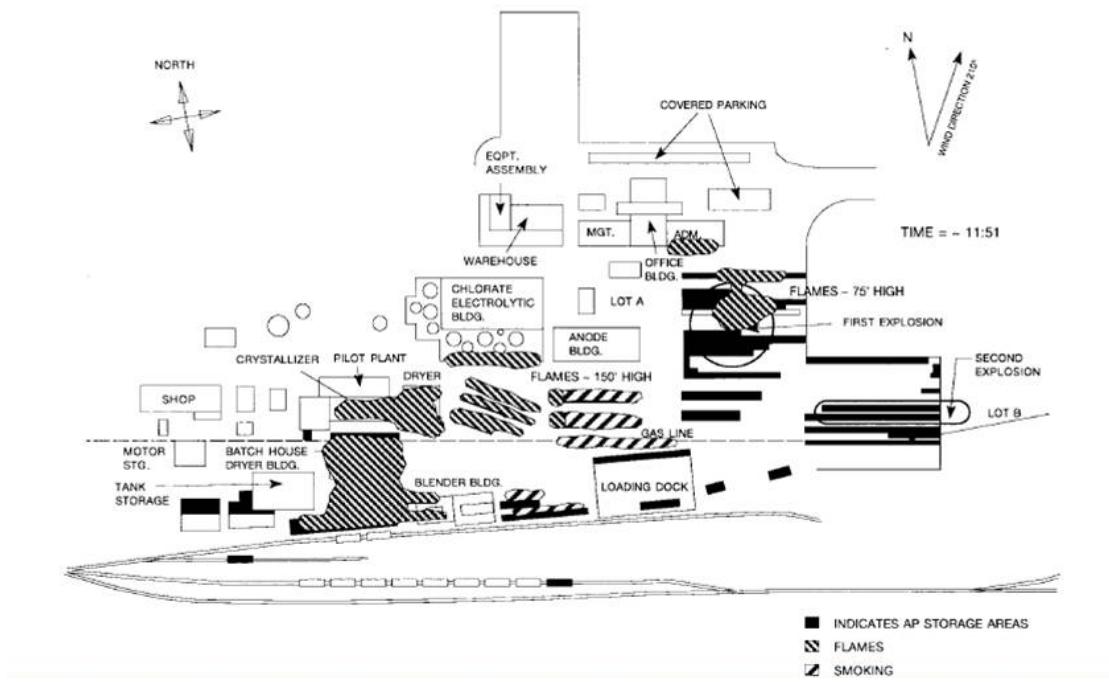
By 11:51 a.m., the flames and areas of smoke have spread as shown in Figure 139. Obviously the brisk wind is driving the reaction towards the northeast.

FIGURE 139. Mapping at 11:51 a.m. Showing Buildings, AP Storage Areas, Flames, and Smoke Locations (Reference 37).

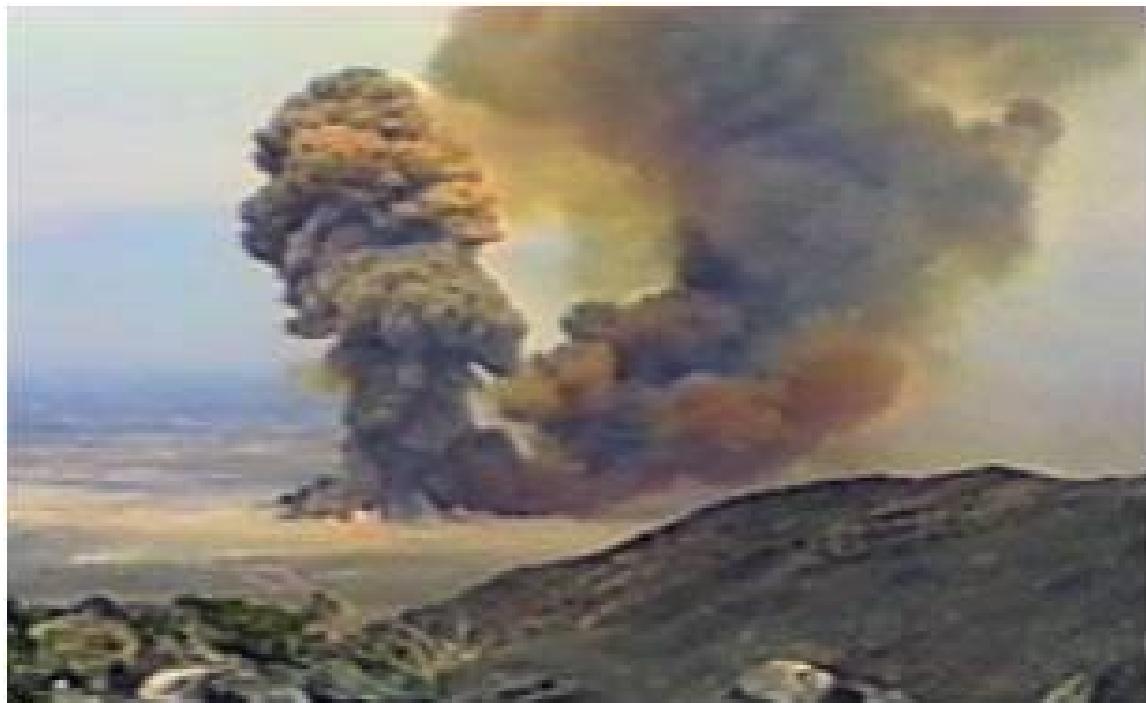
FIGURE 142. Largest Explosion at PEPCON.

This second explosion ruptured a 16-inch, high pressure (300 psi) natural gas line that ran under the PEPCON plant. A flame plume resulted and burned until the Southwest Gas line was shut down at 12:59 p.m.

The heat flux measured in the vent pipe is given in Figure 152.

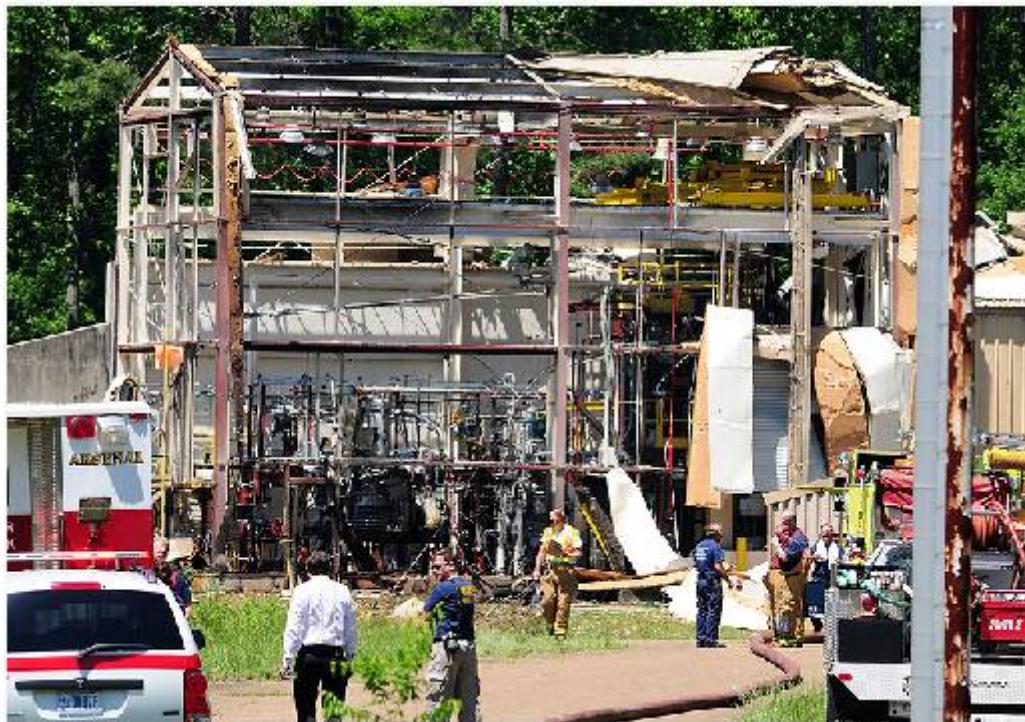
FIGURE 143. Damage to Building 7352, Redstone Arsenal From Explosion That Occurred 5 May 2010.

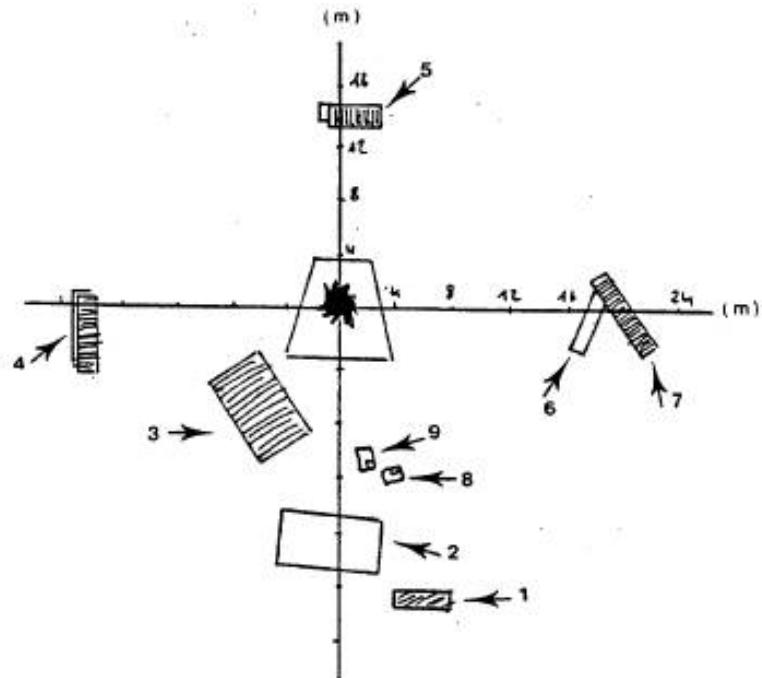
FIGURE 160. Location of Debris (Reference 48).

Test 4 resulted in the igloo bursting 1 second after ignition, releasing a fireball. At ground level, no trace of a plume was observed. The igloo separated along its structural lines or corners. It separated into five main parts, each comprising two pieces—one concrete and one steel as shown in Figure 160.

Interestingly, none of the overpressure gauges recorded any signal, nor did Figure 161b show a crater, indicating neither strong explosion nor detonation occurred. One of the internal overpressure gauges recorded an overpressure of 7 bars before saturating. The author estimated that the maximum overpressure before rupture at 10 to 12 bars.

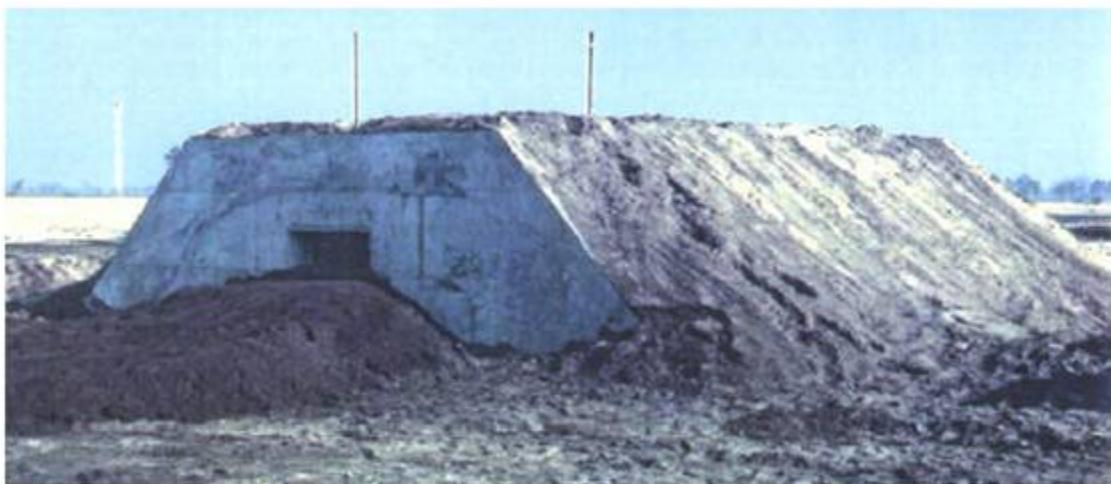
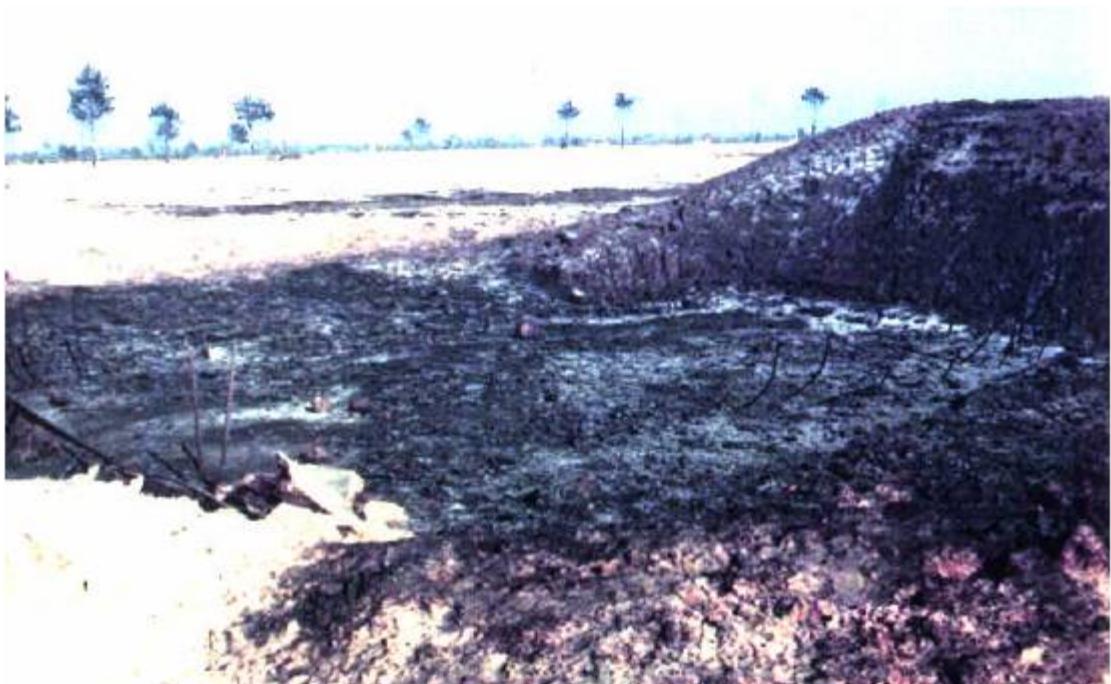
FIGURE 161. Captieux Trial Shot (Reference 48).

Figure 161 shows the igloo before the tests and the post event photograph.

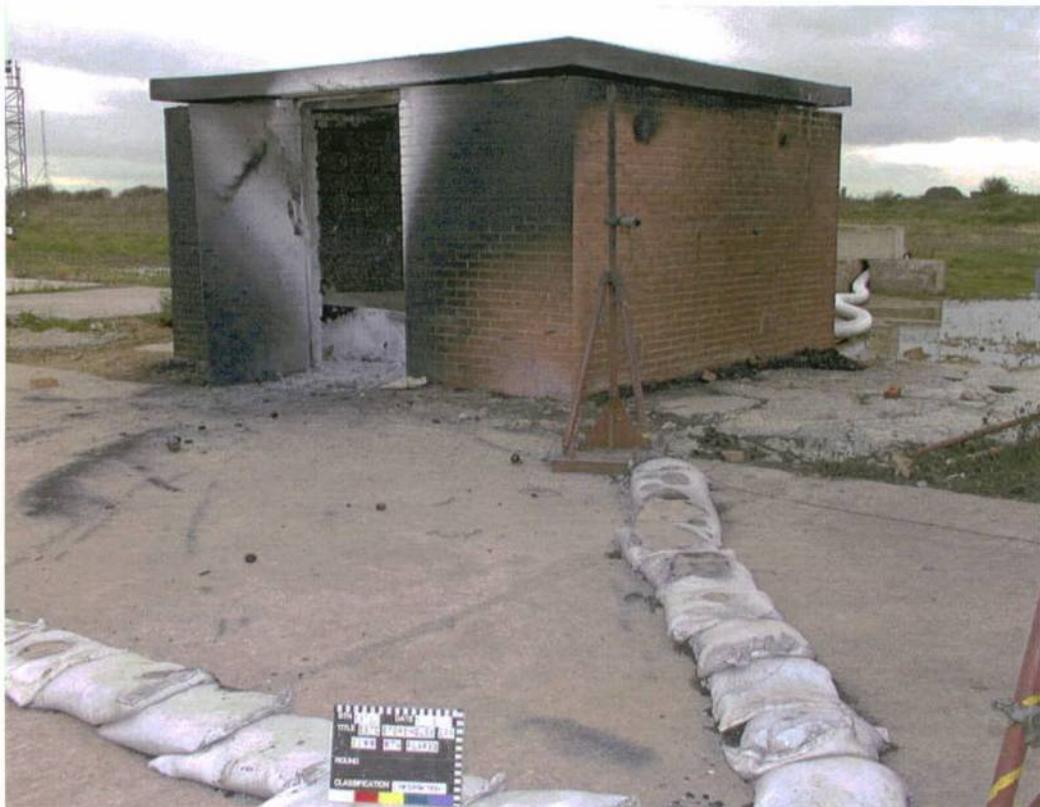
FIGURE 164. Storage Building After Test With 55-mm MTV Flares Subject to Standard Liquid Fuel Fire (Reference 50).

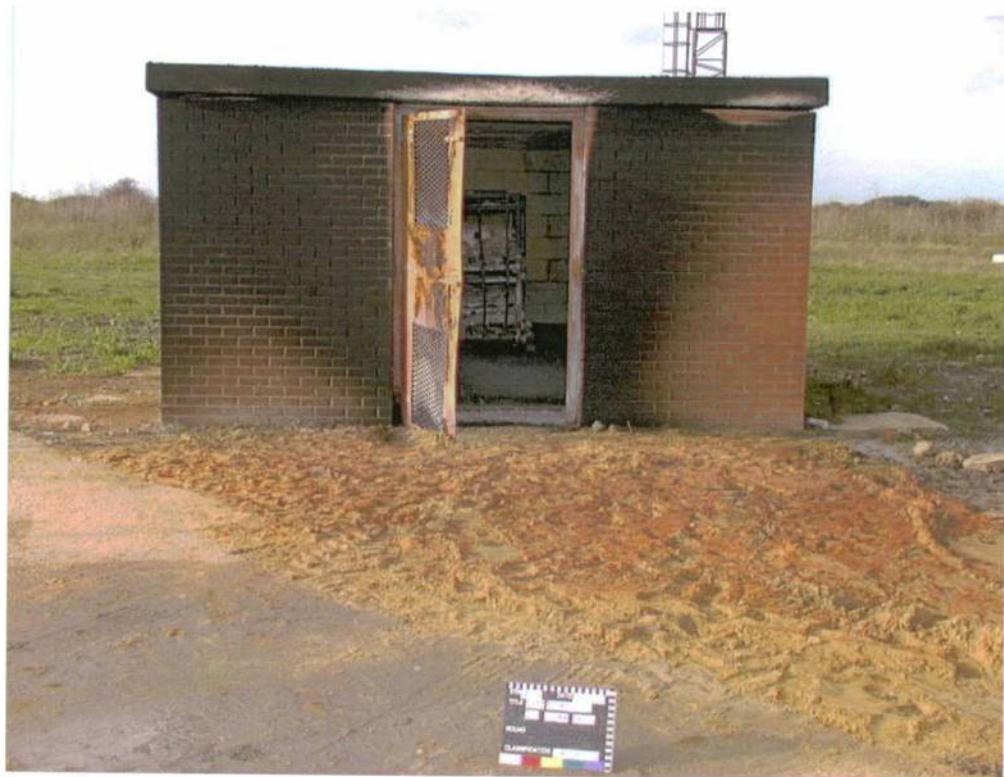
FIGURE 165. Results of the Tests With 155-mm Propelling Charges Subjected to Standard Liquid Fuel Fire Within Building (Reference 50).

Again there is only minor damage probably due more to the long exposure to fire rather than reaction violence of the ordnance.

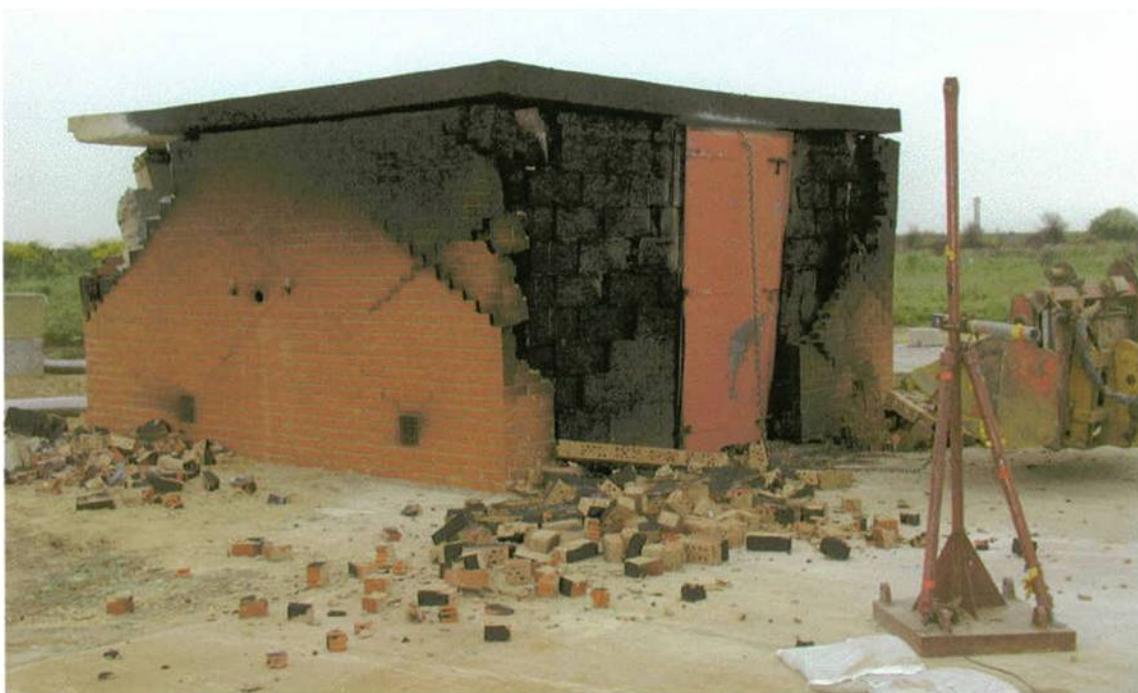
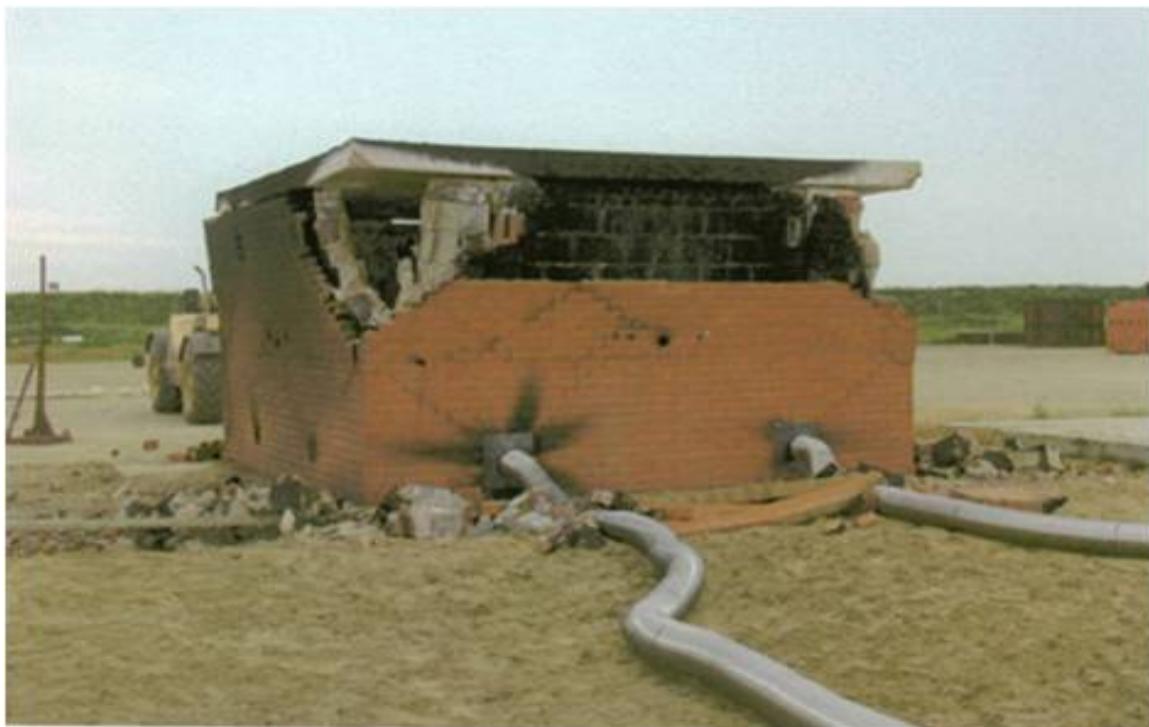
FIGURE 166. Result of 120-mm Propelling Charges Subjected to Standard Liquid Fuel Fire in Building (Reference 50).

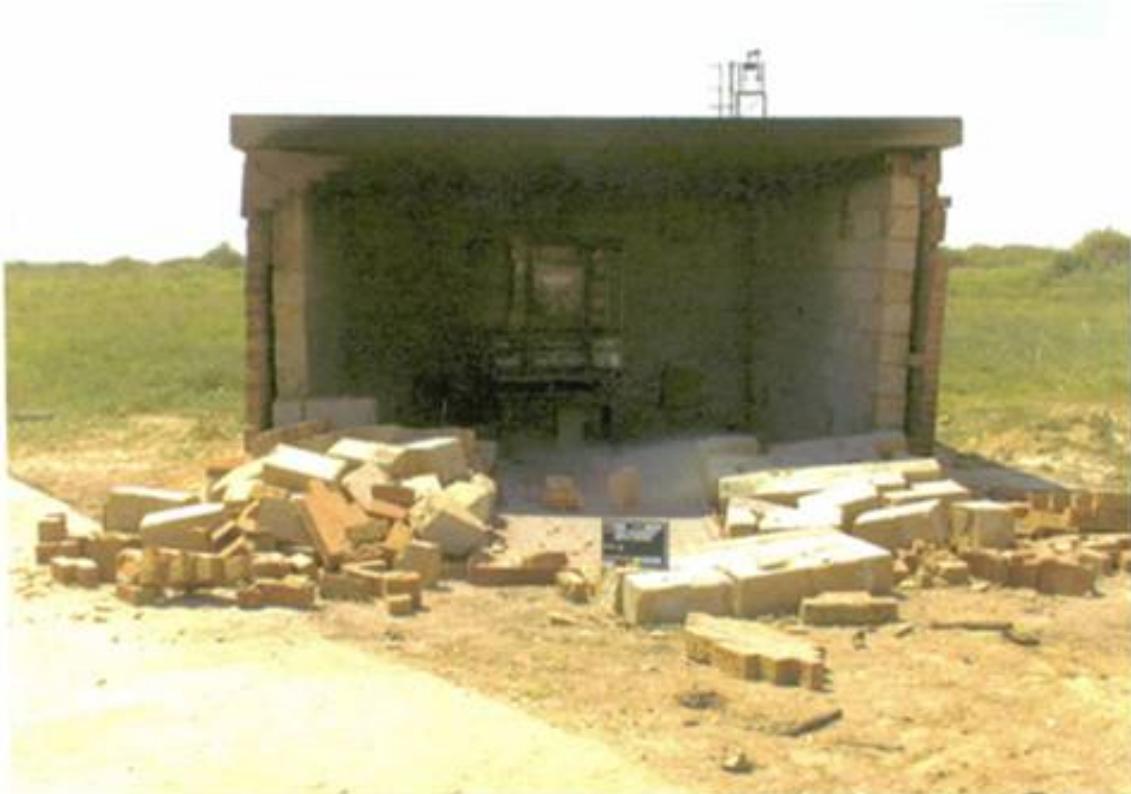
FIGURE 167. Effects of Functioning 120-mm Propelling Charges When Contained Within an Explosive Storehouse Structure, View of Front of Magazine (Reference 50).

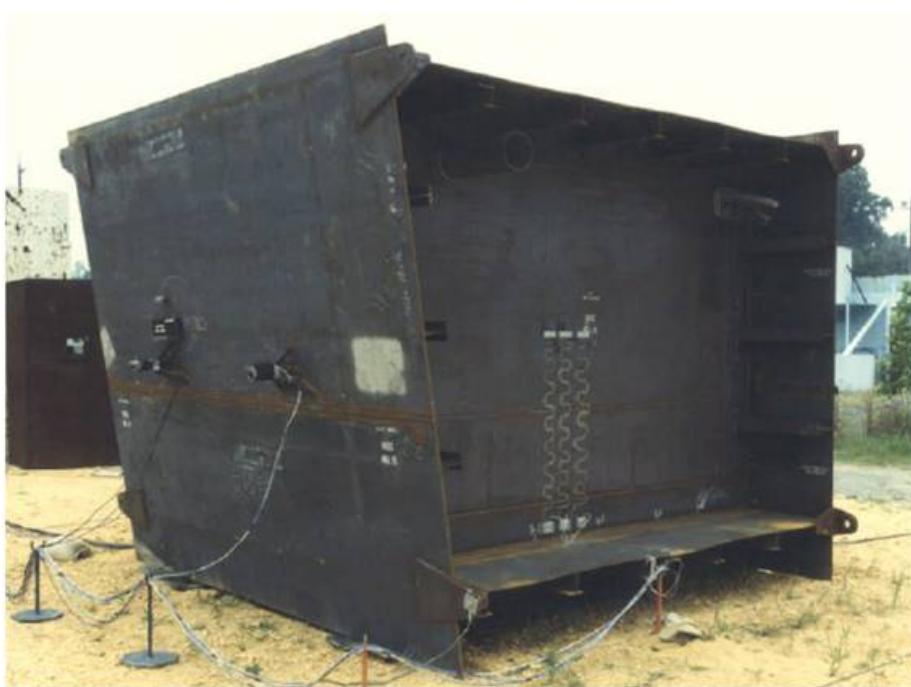
(a) Before.

Swisdak and Montanaro (Reference 53) presented what they called “Real World Events.” The first of these were tests performed at the Naval Surface Warfare Center, Carderock, that used burning propellant to provide internal pressurization for testing ship structural components. Figure 168a shows one of these test fixtures having nominal dimensions of 9 feet x 8 feet x 12.75 feet and a volume of 918 ft<sup>3</sup>. When approximately 300 pounds of propellant were burned in this fixture (loading density of 0.33 lb/ft<sup>3</sup>), the catastrophic failure shown in Figure 168b occurred.
